# Thermal imaging of railroad cars used for molten iron transport

Christopher A. Sahr

SES Technical, Inc.  
3319 Greenfield Rd.. Box #181  
Dearborn, Michigan 48120

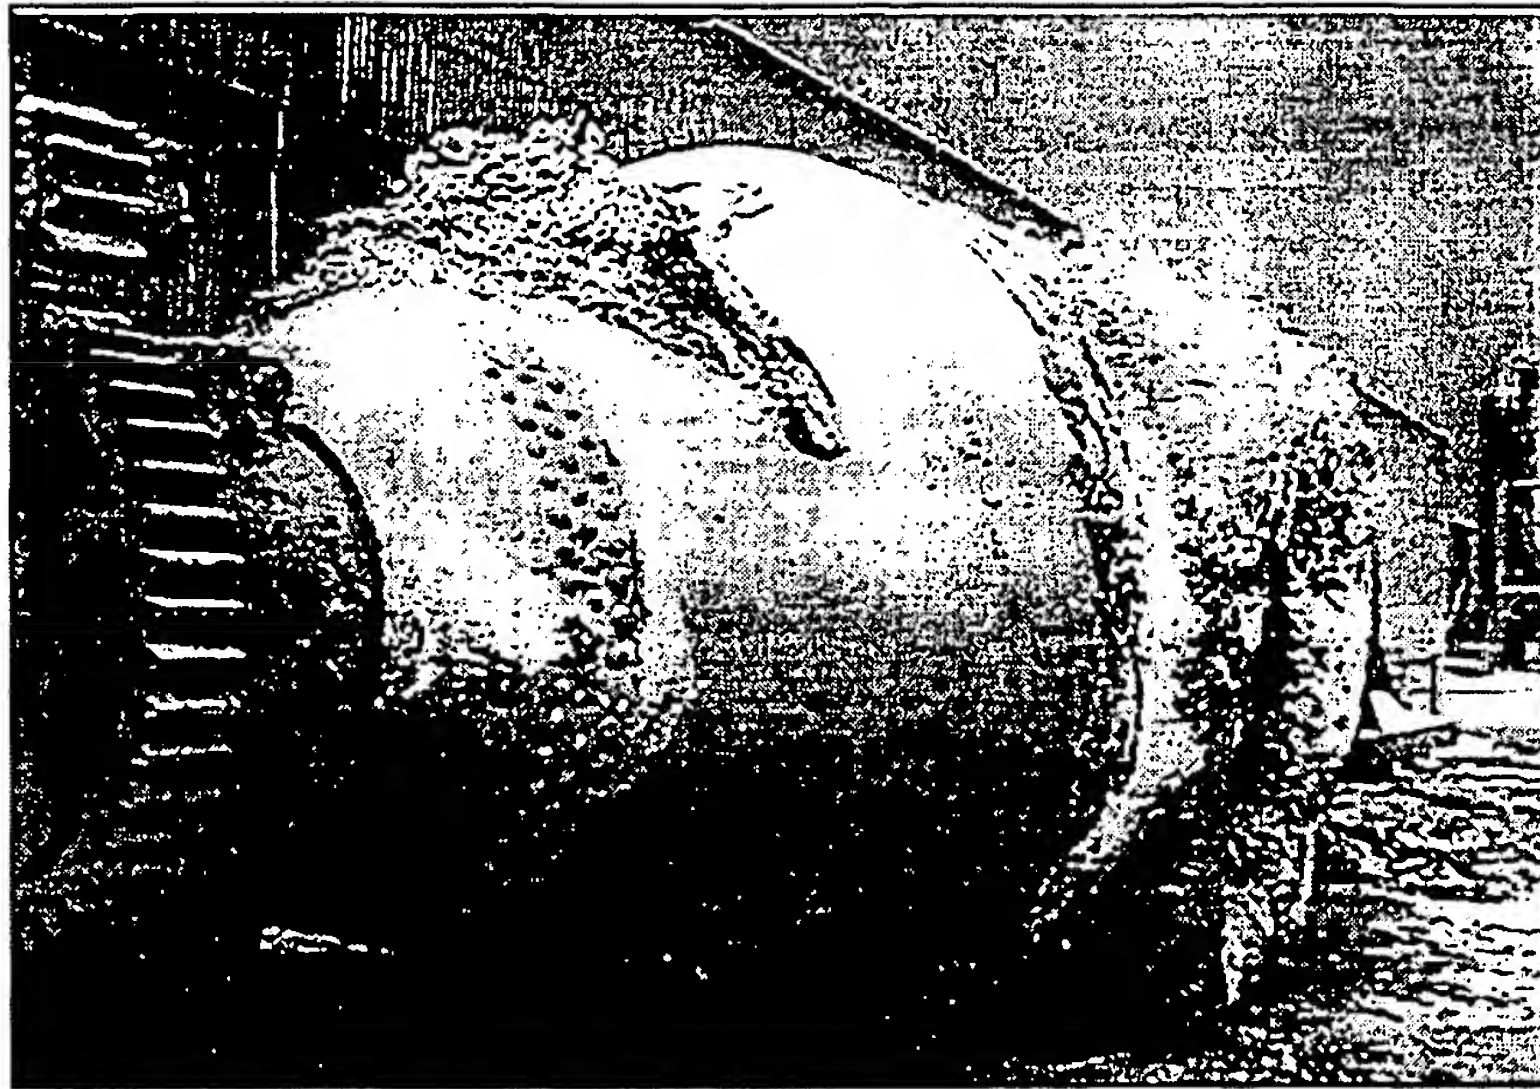
The occurrence of a spill can be extremely costly to a company. The value of the molten iron spilled can conservatively range from \$10,000 to \$40,000 depending on the car capacity and current market value. The damage to the railroad car can cost several hundred thousand dollars to repair and can require complete replacement. If the spill damages a critical point on the railroad track the transportation of any molten iron may be halted for several hours until the railroad car can be removed and the track repaired. The stopping of production can conservatively cost between \$10,000 to \$50,000 dollars per hour depending on the size of the blast furnaces that are losing production. The point to be made is a small leak can cost a company several hundred thousand dollars and very likely much more. (*see image 2*)

Image 2: Pugh-type molten iron railroad car after metal breakout

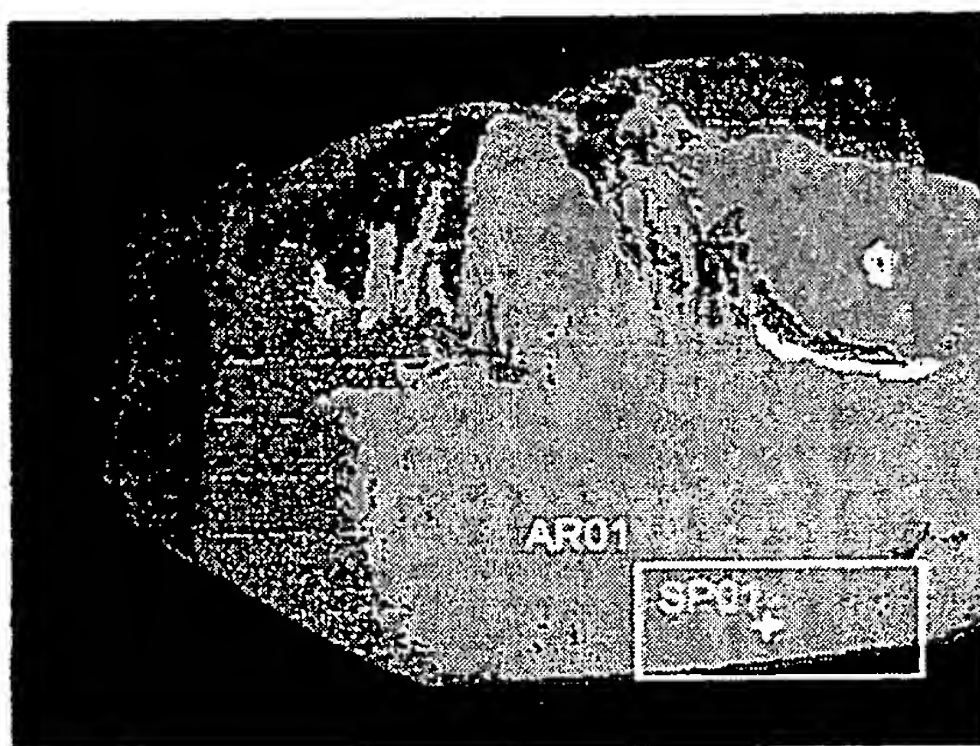
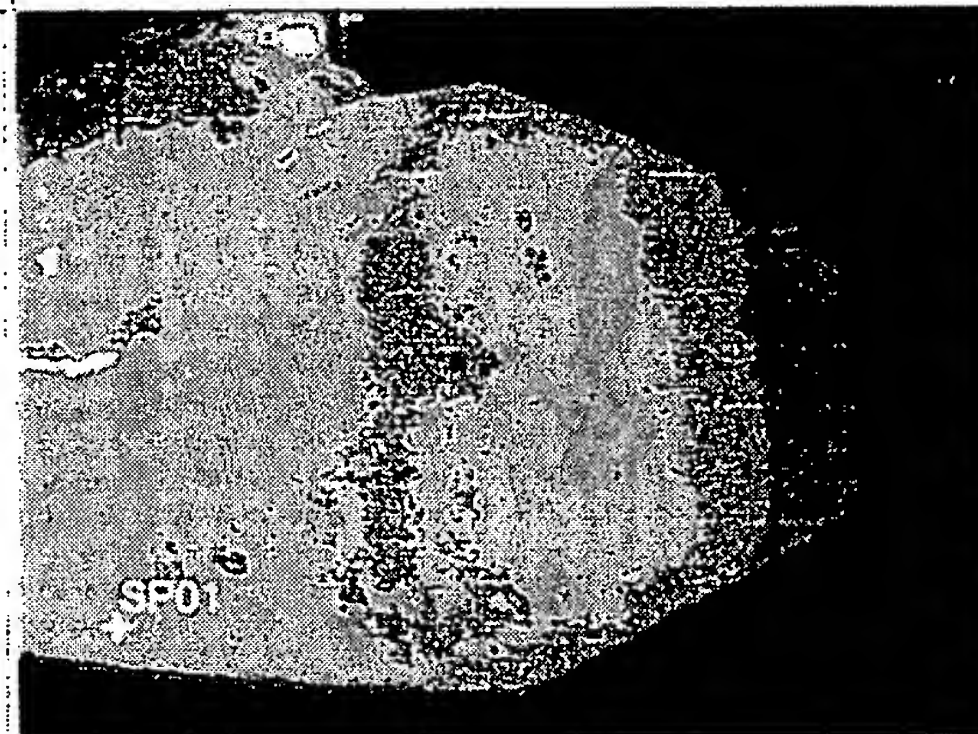
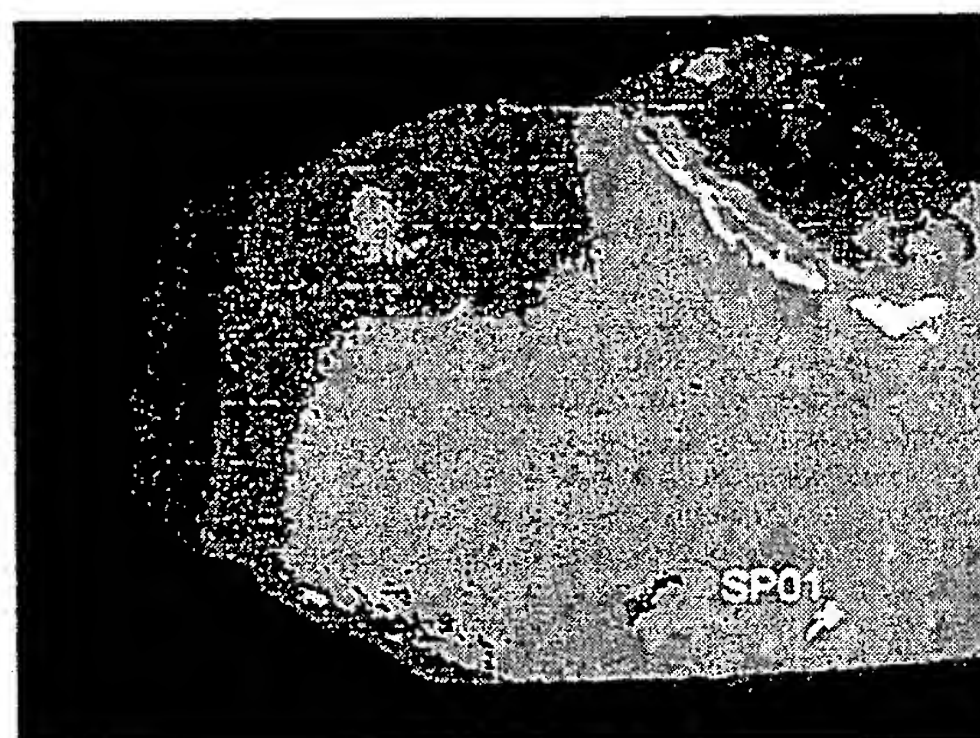
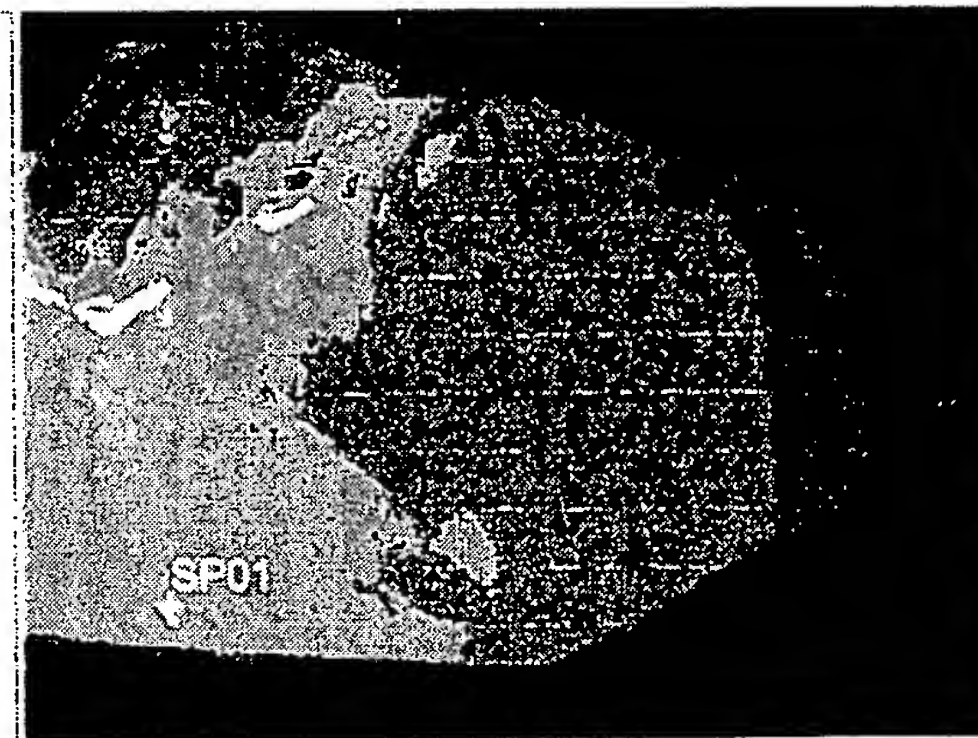
Image 6. Sample Report

Ladle Number	Total Tons	Tons on Gun	Status	High Temp	Temp Diff
113	158000	18500	within parameters	329	124
